PARKER POND
NDI NO. MD 00085

PHASE I INSPECTION REPORT
NATIONAL DAM INSPECTION PROGRAM

Prepared By: Maryland Water Resources Administration
AUGUST 1978

Name of Dam: Parker Pond Dam
State Located: Maryland
County Located: Wicomico
Stream: Beaver Dam Creek
Date of Inspection: 14 July 1978
Inspection By: State of Maryland
Department of Natural Resources
Water Resources Administration

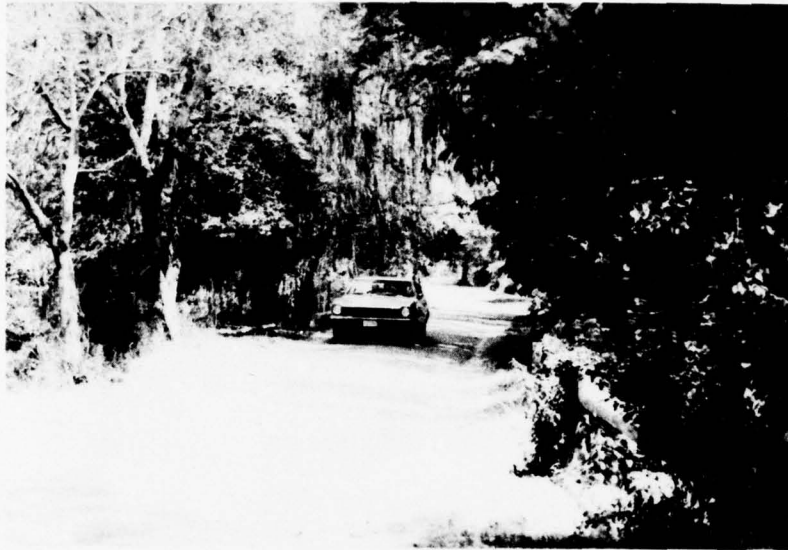
Top of dam
east view

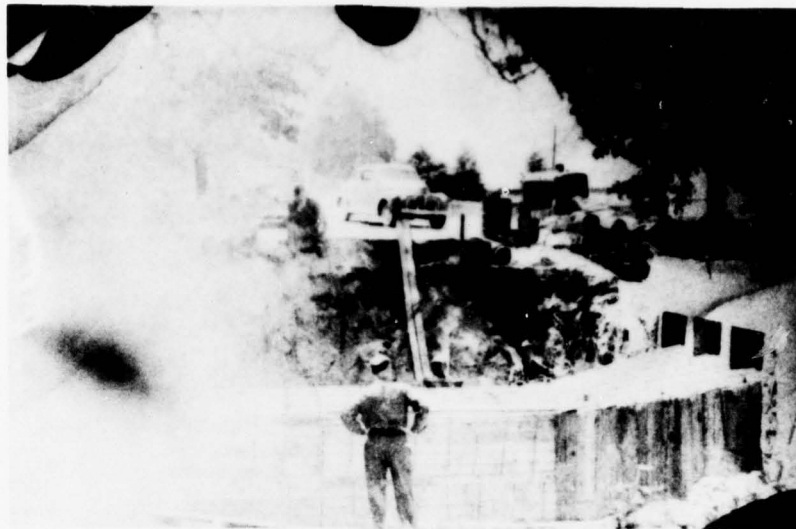
(Photo reproduction) construction of
west (hydroelectric) spillway 1956

In 1956 an automobile left the road way and totally destroyed the old mill house and part of the spillway wingwall (downstream side). The mill was removed. Also in 1956 the right side of the dam washed out due to internal erosion. The spillway was replaced with a concrete flume containing hydroelectric equipment. (two twin turbines)

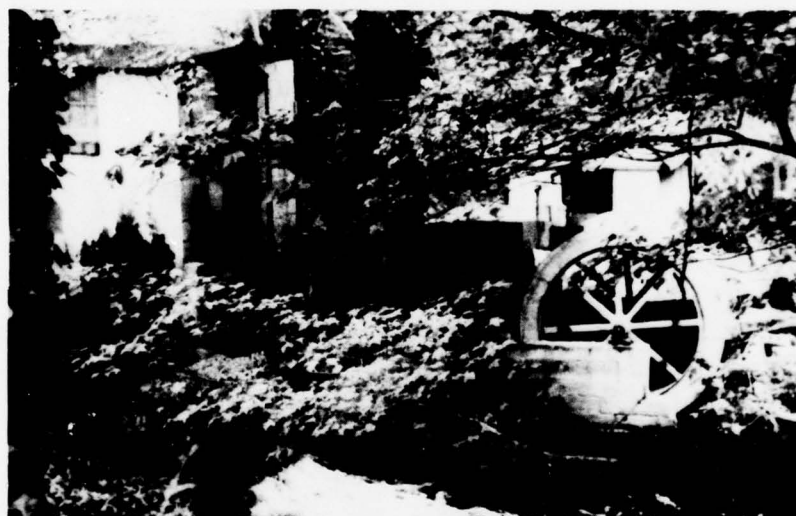
Downstream view of west (hydroelectric)
spillway

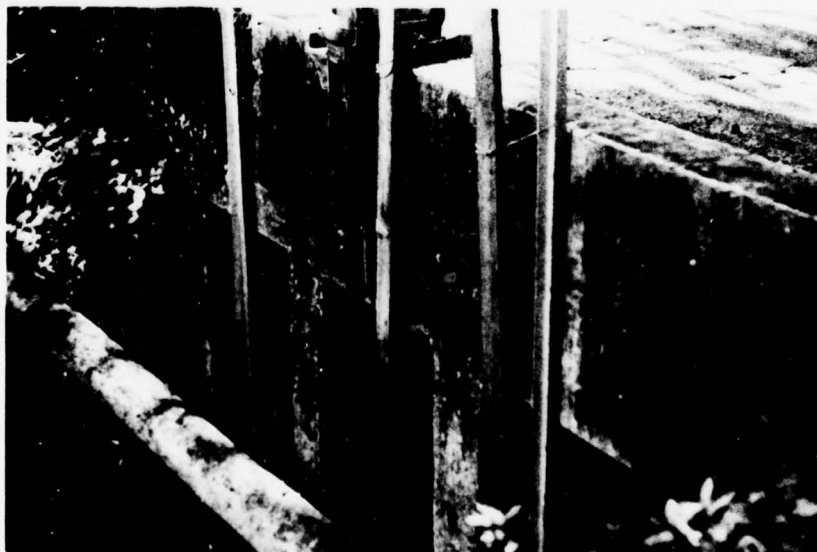
East spillway
upstream face

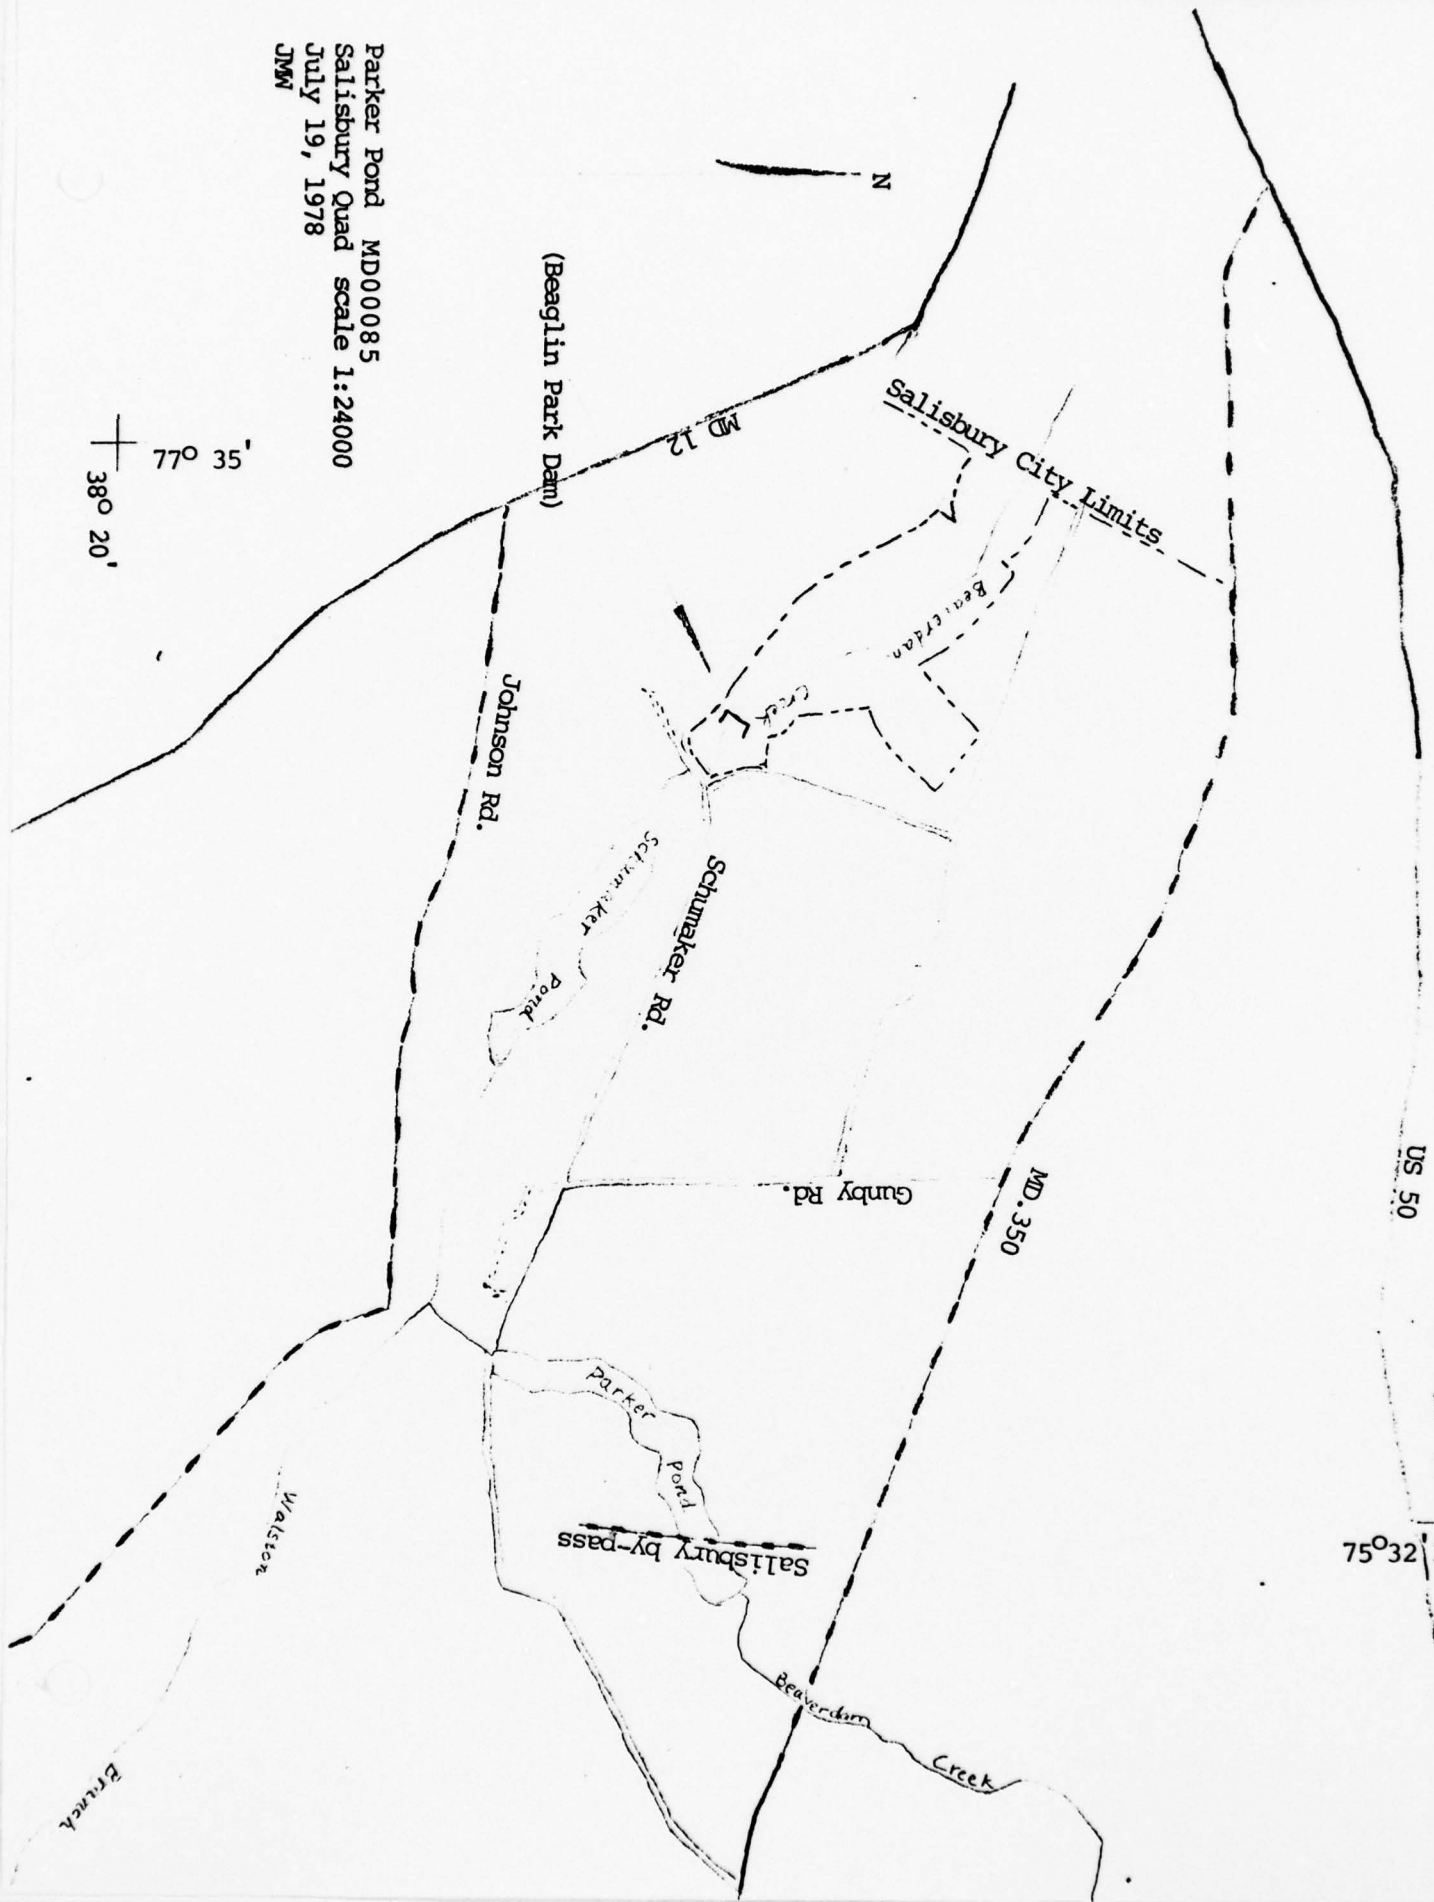
Top view Parker Pond 00085
scale 1"=50'

unplanned overflow
area along paved
road

stream channels converge
1/8 mile downstream
